**DEPARTMENT OF ENVIRONMENTAL MANAGEMENT
INDIANAPOLIS**

OFFICE MEMORANDUM

SUBJECT: Site Visit Summary for Ecological Systems Inc. conducted on October 19, 2010, located at 4910 West 86th Street, Indianapolis, Marion County, Indiana.

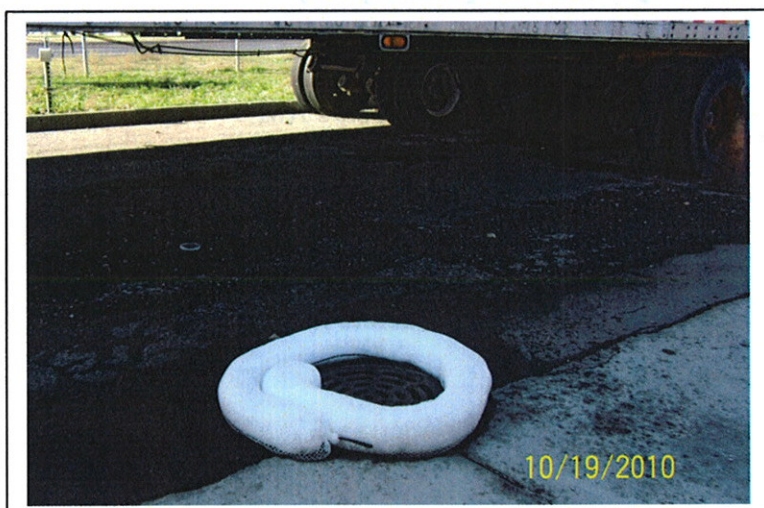
Location & Description: View of manhole identified as SS2. Potential for Oil and Grease is moderate to high due to it being located next to the truck sampler.

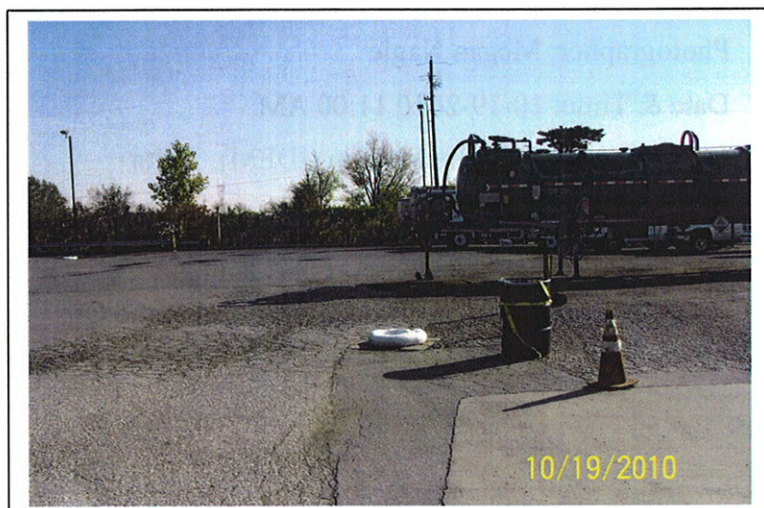
Location & Description: View of manhole identified as SS3. Receives runoff from truck sampler.

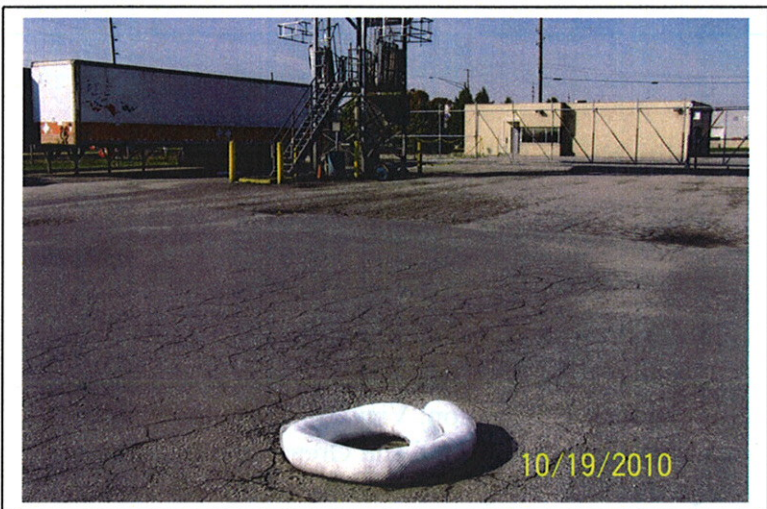
Location & Description: View of manhole identified as SS4. SS4 is a low point and the potential for O&G is moderate to high.

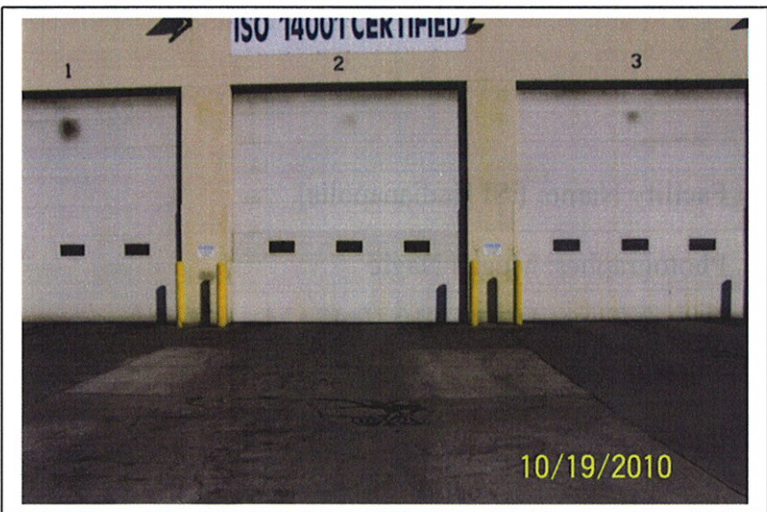
Location & Description: View of manhole identified as SS5, potential for O&G is high. SS5 receives roof runoff, and the runoff drains to the Oil Pit on opposite side of truck unloading building.

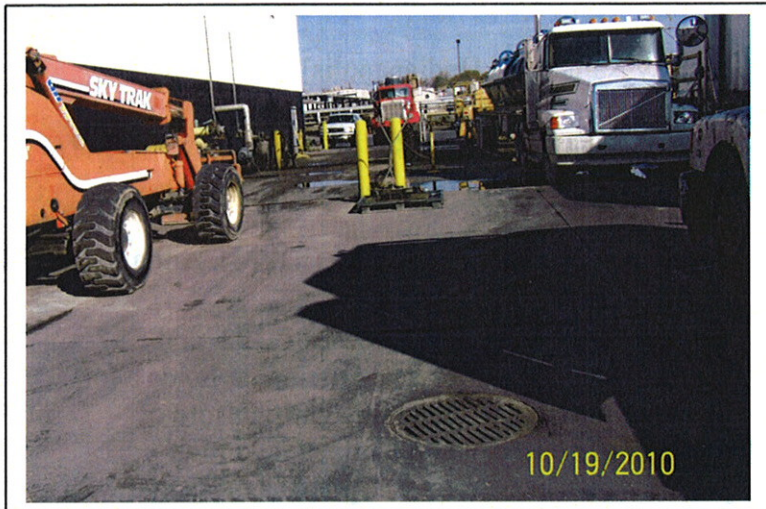
Location & Description: View of manhole identified as SS6. The potential for O&G is high, receives roof drain runoff. Drains to Oil Pit on opposite side of truck unloading building.

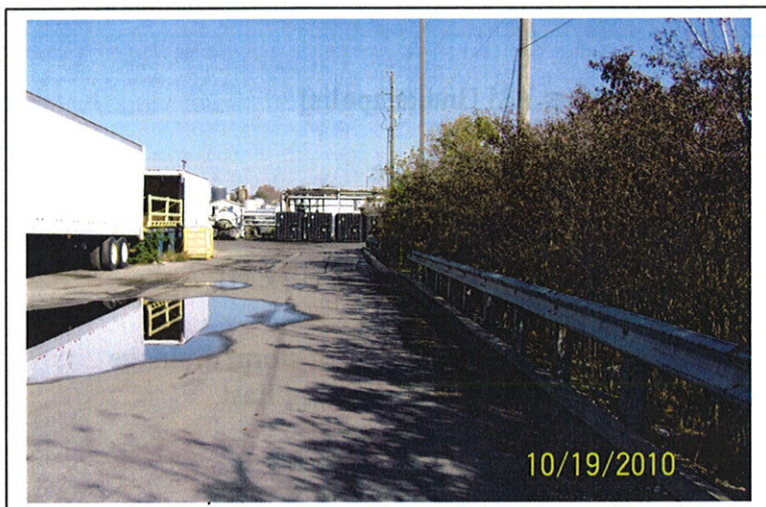
Location & Description: Potential Discharge Point (PDP) 1 located south of the scale, along the eastern border of the property. Without containment or pumping of storm drains a heavy rain event could cause sheetflow from this drainage area to the tributary to Oil Creek.

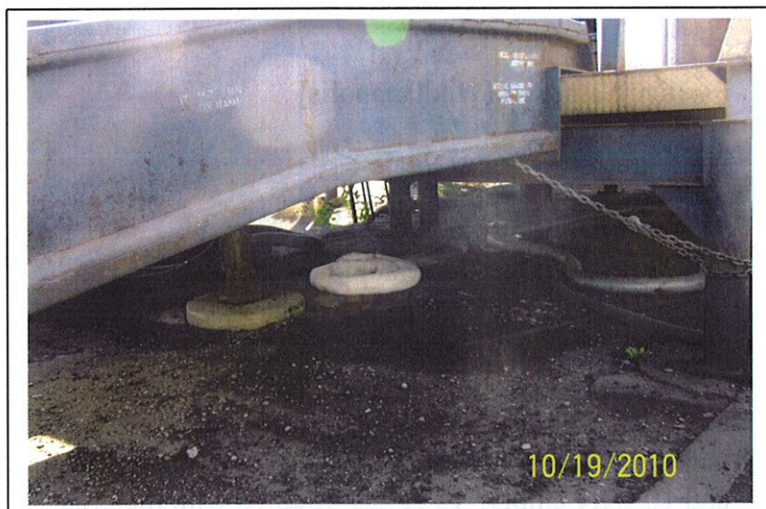
Location & Description: View of SS8. Located beneath the tote/drum unloading dock. Potential for total suspended solids (TSS) and O&G is high.

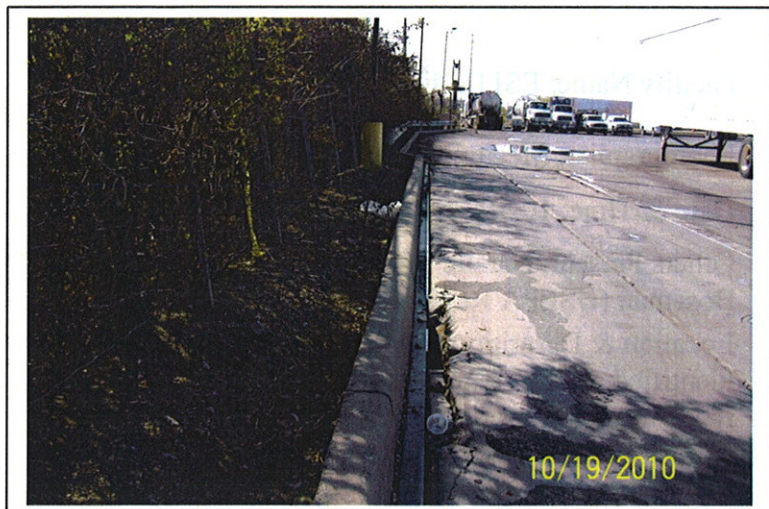
Location & Description: View of PDP2 and SS7 (in distance). The truck scale perimeter holds a lot of water, possible seepage thru curb, unsure of integrity of structural containment, and high potential for O&G. Water depth was measured with a drum sampler at 3'8" and there is a potential for sludge build-up at bottom.

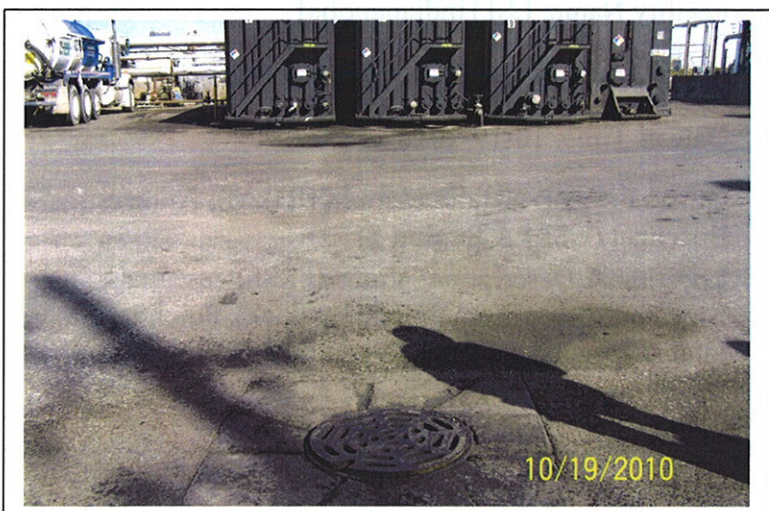
Location & Description: View of SS9, extremely low point, receives runoff from used oil frac tanks, and visibly stained surface. There are four frac tanks in the background (7, 8, 9, 10). Frac tank 7, 9, and 10 were empty. EPA has filled 10 with material pumped from storm sewers. Each tank holds 22,000 gallons.

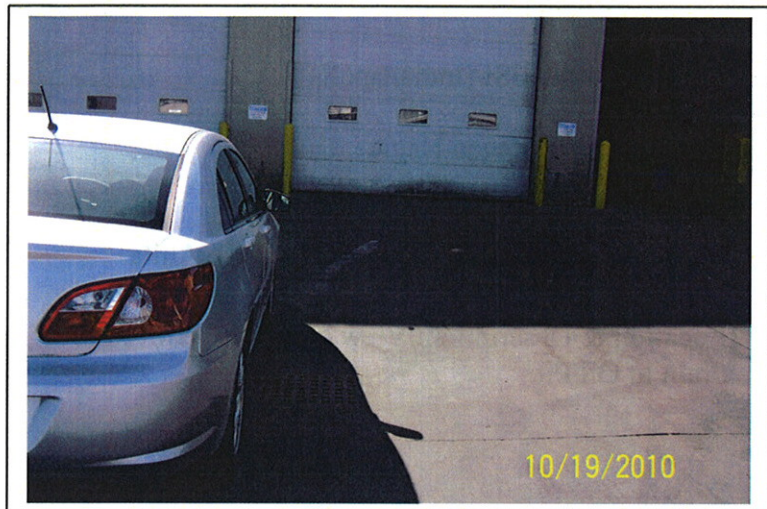
Location & Description: View of SS11 located north of Building 1. The concrete surrounding the drain is stained, receives runoff (contaminated Building 1 north side). Believed to drain to Oil Pit.

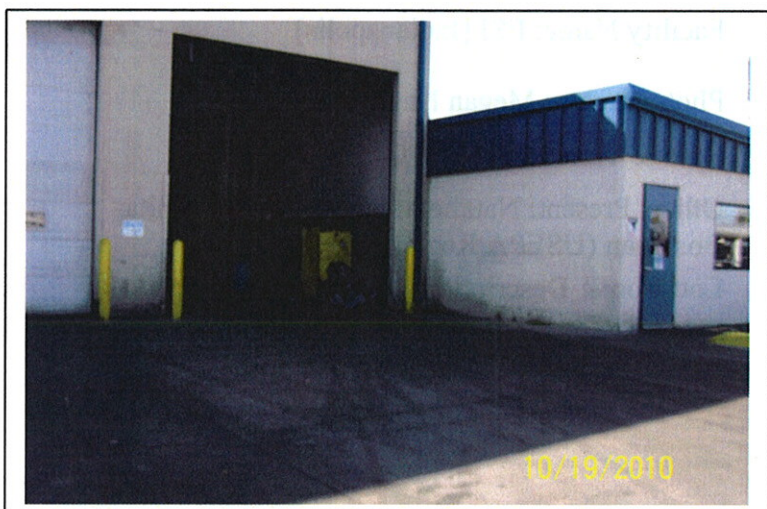
Location & Description: View of roof drain on Building 1 and stained concrete.

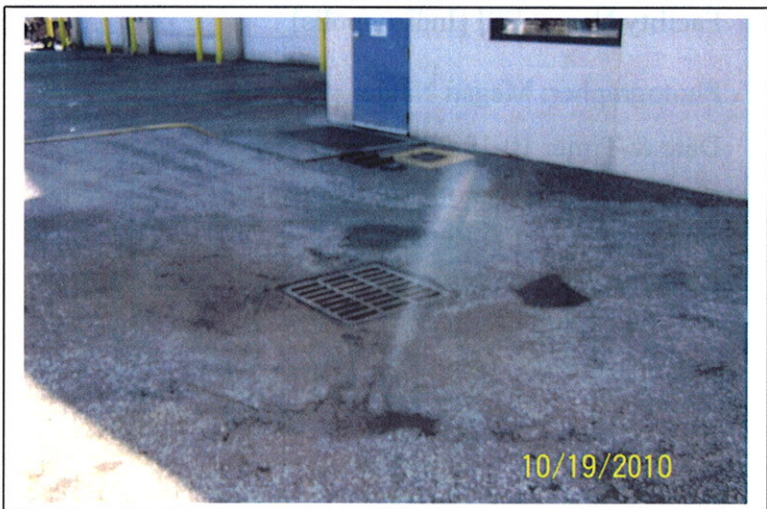
Location & Description: View of SS12. Receives roof drain runoff from Building 1 (northwest side). Believed to drain to Oil Pit.

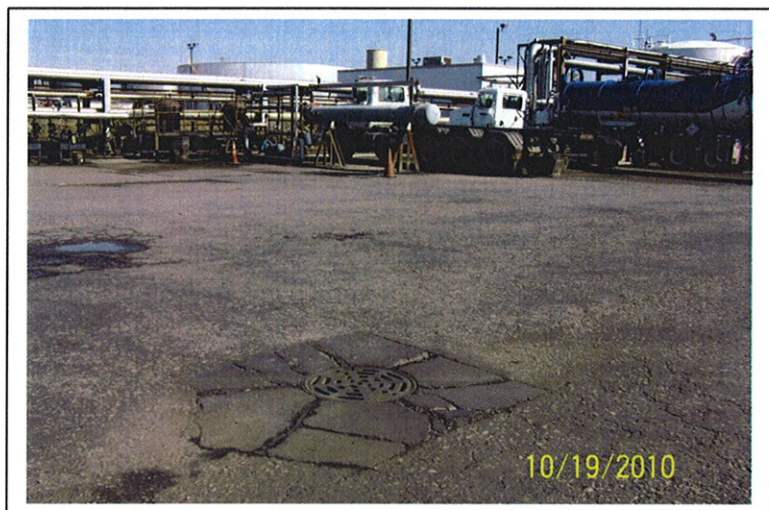
Location & Description: View of SS15, receives runoff from immediate parking lot area. High potential for TSS and O&G from stained area.

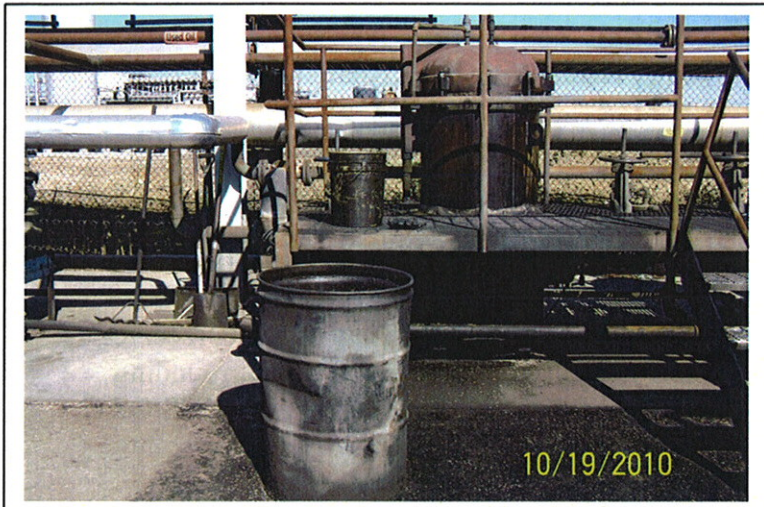
Location & Description: Stained surfaces next to loading station.

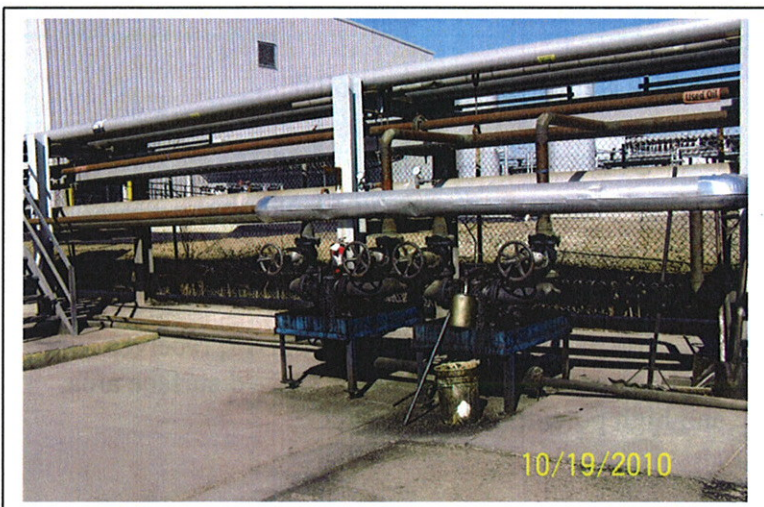
Location & Description: Stained surfaces next to loading station.

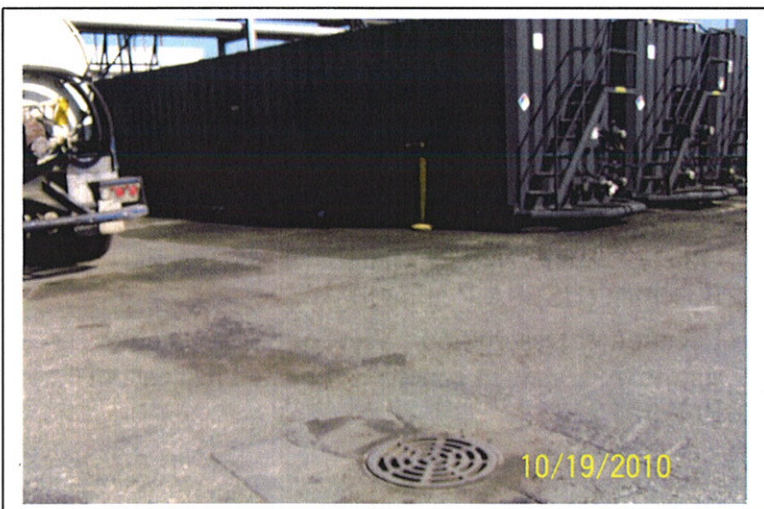
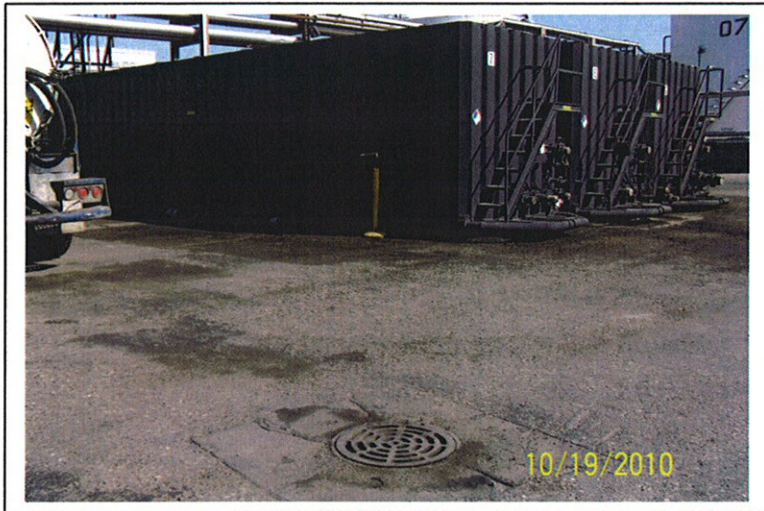
Location & Description: View of SS16, receives runoff from used oil frac tanks, and surrounding stained surface area. High potential for TSS/O&G.

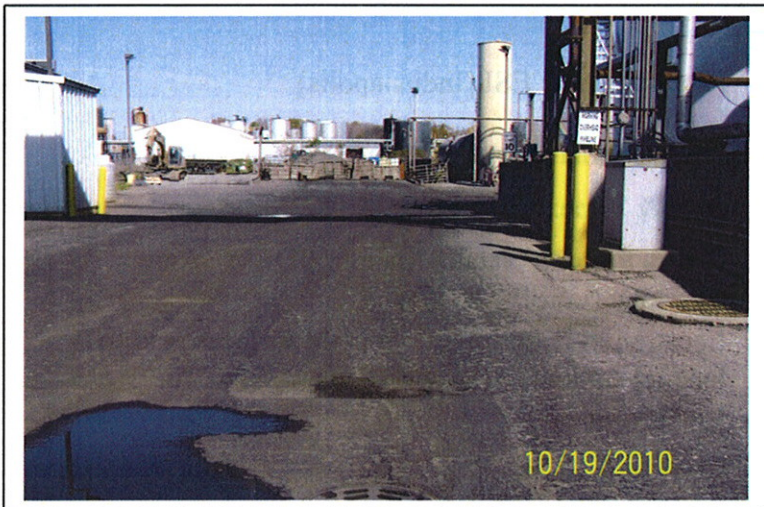
Location & Description: View of SS17, receives runoff from used oil frac tanks, stained surface area, and high potential for TSS/O&G.

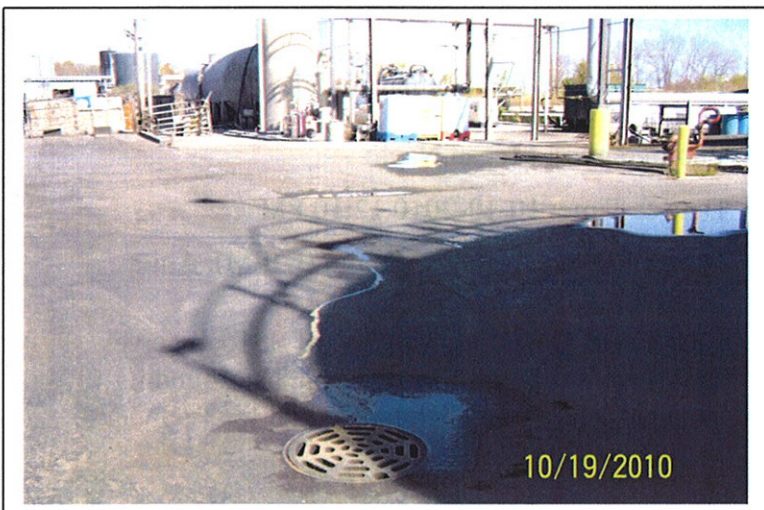
Location & Description: View of SS19, receives runoff from stained concrete. Located just east of Building 2.

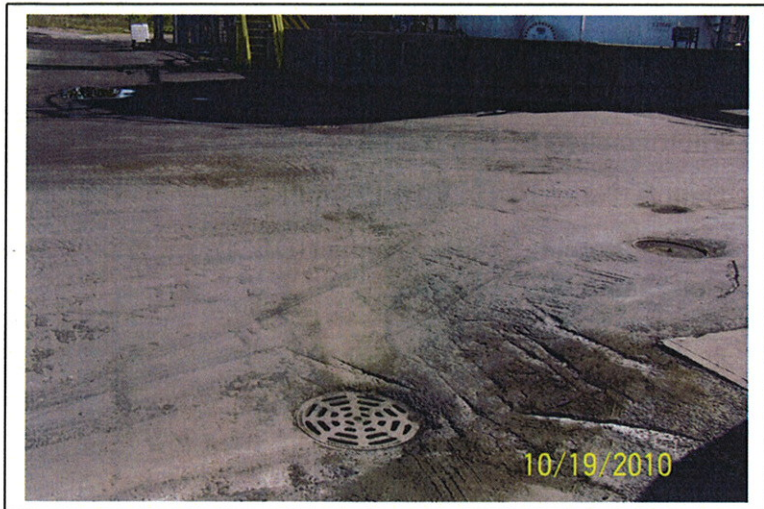
Several storm sewers appeared to be used for improper disposal of materials (unknown). This observation was documented in photos of the storm sewer inlet titled SS20, SS22, and SS25. Further discussion of the status of the Site and potential for pollutants on site is discussed within the photographic documentation (attached).

Location & Description: View of SS20, receives runoff from roof drains from northeast corner of Building 2.

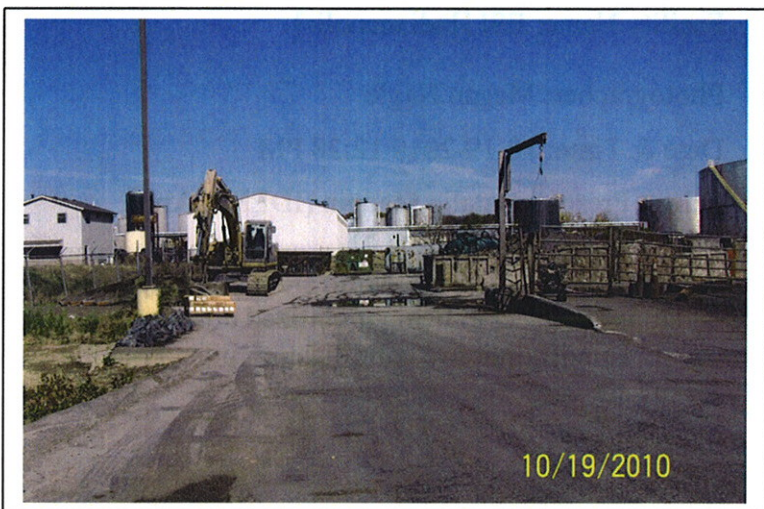
Additionally, ESI left waste materials exposed and uncontained. The waste materials include oil sludge located near the oil solidification pits, uncontained fly ash, and oil/oily residue. The volume of the left over oil sludge has been estimated to be approximately two truck loads. The secondary containment surrounding the “finished product” –

Location & Description: Stockpiled oil sludge area, surface drainage puddles or flows back into pits.

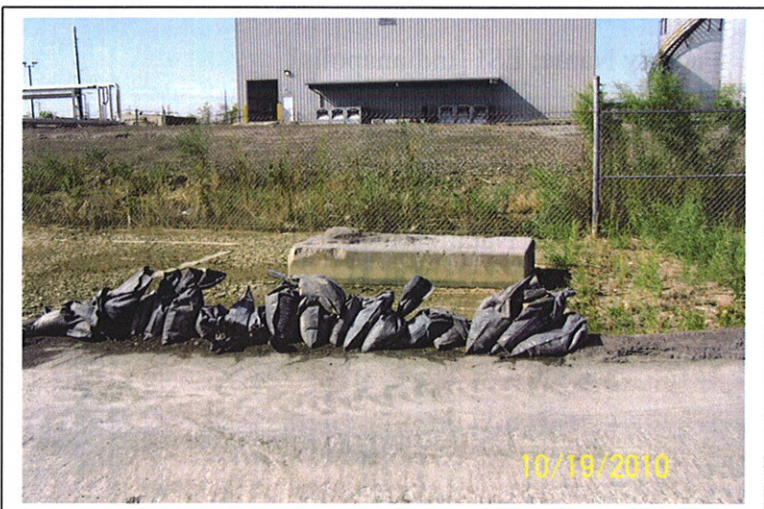
Location & Description: breach in berm, located near oil sludge storage.

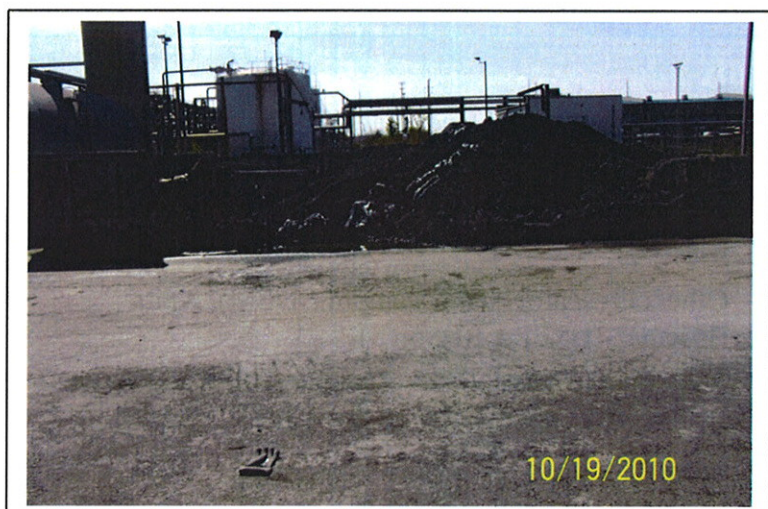
Location & Description: North side of stockpiled oil sludge, subject to being mobilized during a rain event. Runoff drains to solidification pits. Potential for off-site discharge is low.

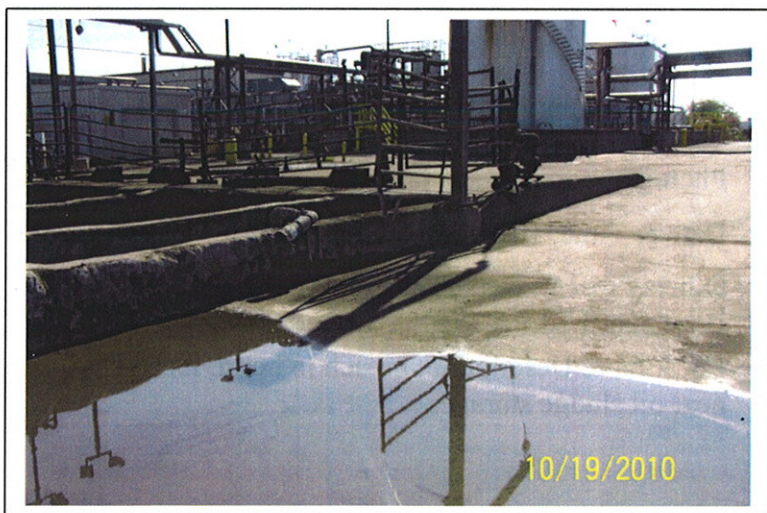
Location & Description: Pooling water near the solidification pits.

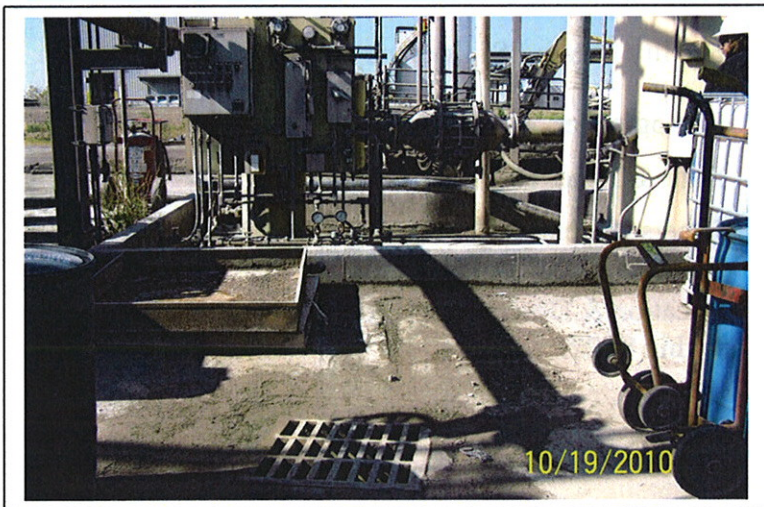
recycled oil" tanks was holding oil and water. The tank used to store fly ash was left open, and due to poor housekeeping and lack of material management the material was not contained within the primary holding tank, nor was it contained within the secondary containment. The secondary containment for the fly ash appears to be plumbed to drain to the storm sewer system.

Location & Description: View of SS21, receives secondary containment water from fly ash tank, tank is open and waste is exposed.

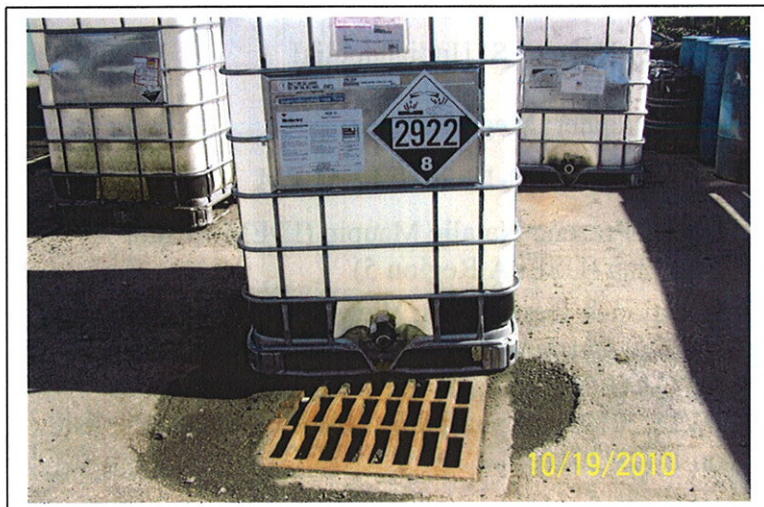
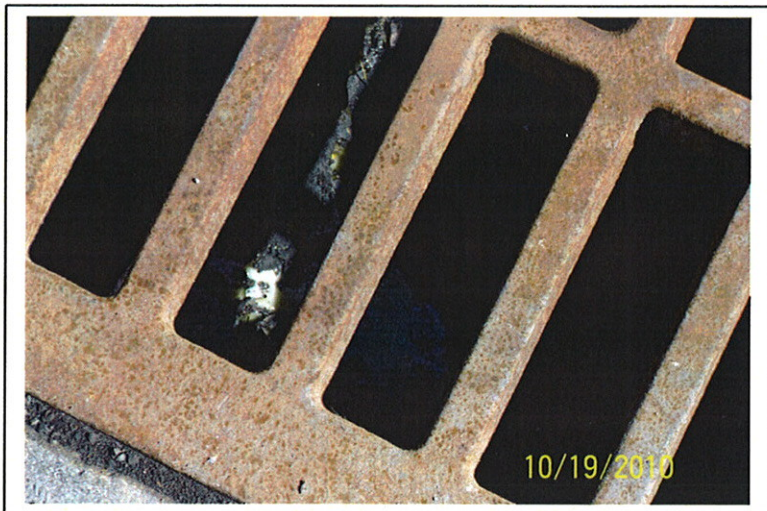
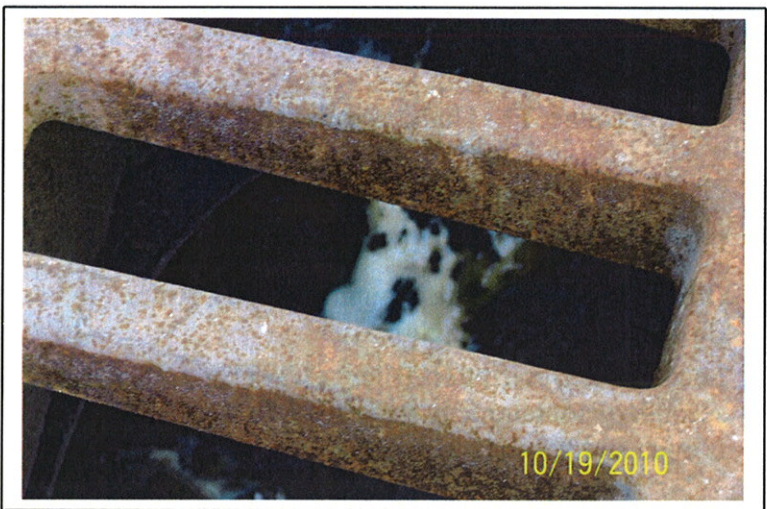
Location & Description: View of SS22, next to empty totes, heavy solidification in drain. Appears that totes were emptied directly into the drain.

Location & Description: View of materials within SS22.

Location & Description: Close-up view of materials within SS22.

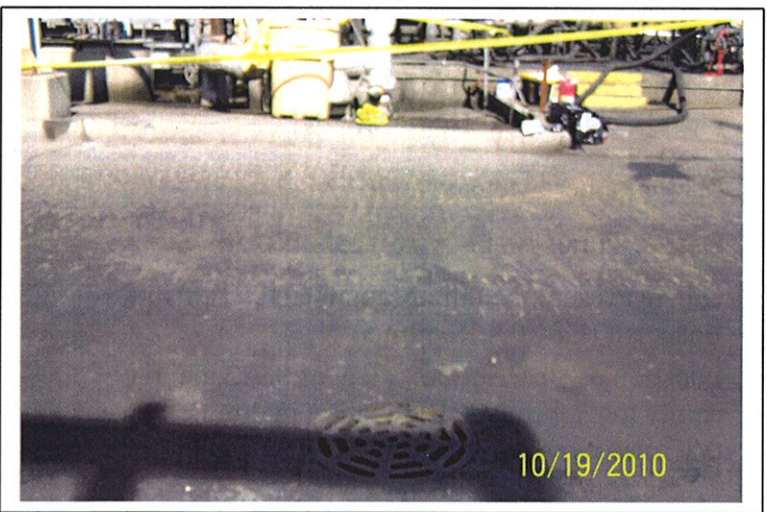
Location & Description: View of SS23, heavy staining surrounding the drain with a high potential for O&G. Pumping of the drain was initiated on 10/15/2010, still pumping at the time of the site visit on 10/19/2010.

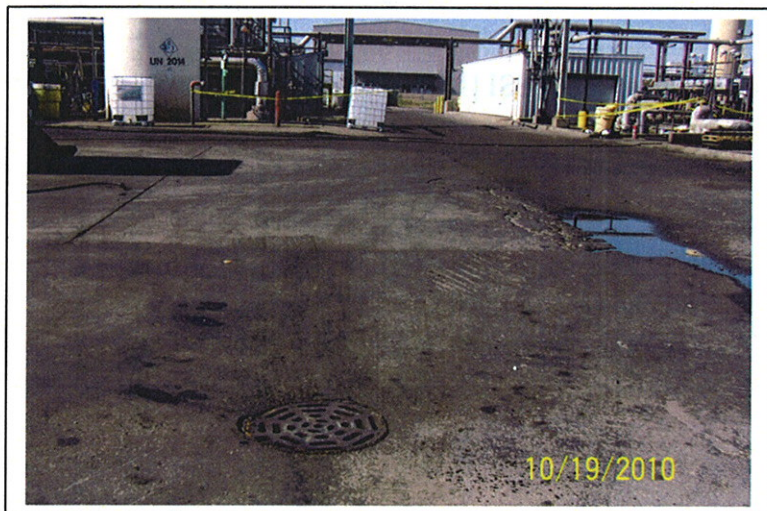
Location & Description: View of SS24. Surrounding area is heavily stained, high potential for O&G, receives runoff from Building 5. This is the drain which EPA proposes to attach a culvert pipe and discharge from storm sewer system to tributary to Oil Creek.

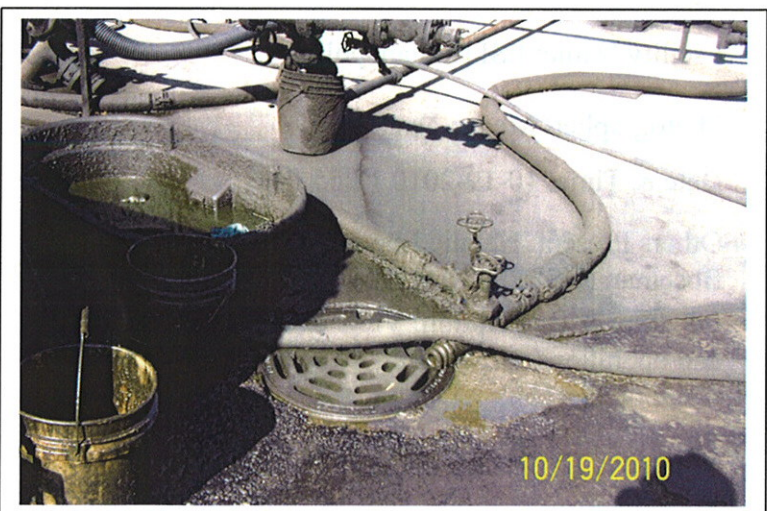
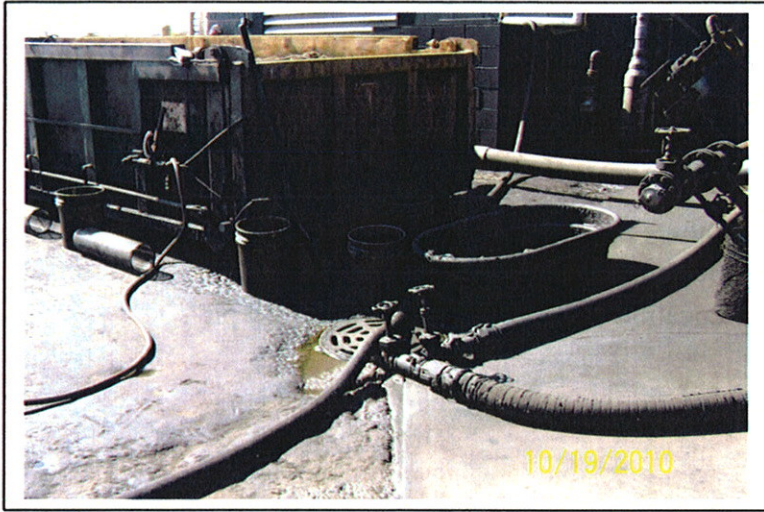
Location & Description: View of SS25. HEAVILY STAINED. Located East of Building 5. High potential for O&G.

Location & Description: Additional view of SS25. It appears there were oil wastes being pumped directly into the storm drain.

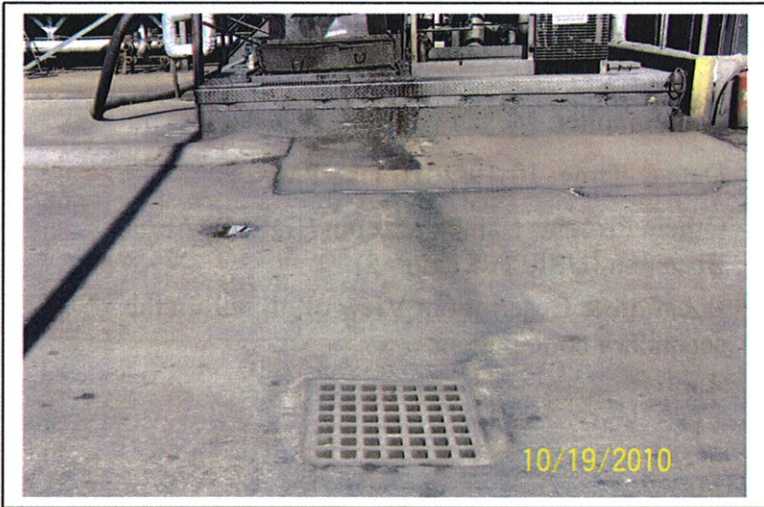
Location & Description: View of SS28, heavily stained. SS28 receives runoff from area contaminated by "Fry Basket".

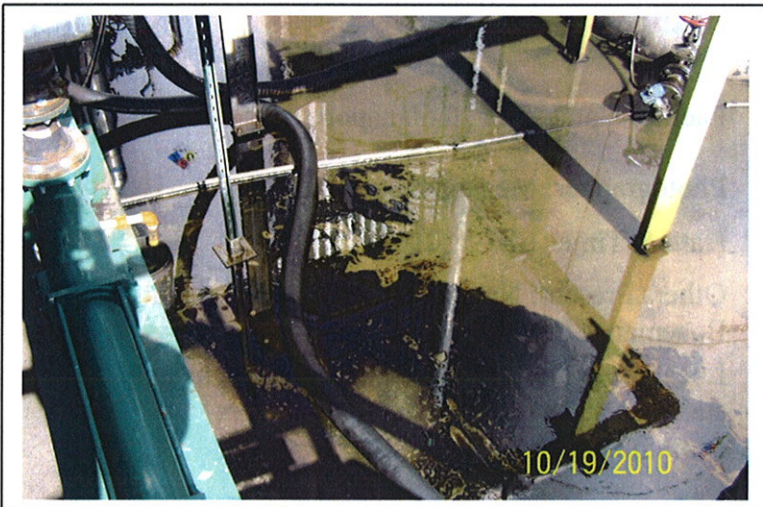
Location & Description: View of oil within the secondary containment.

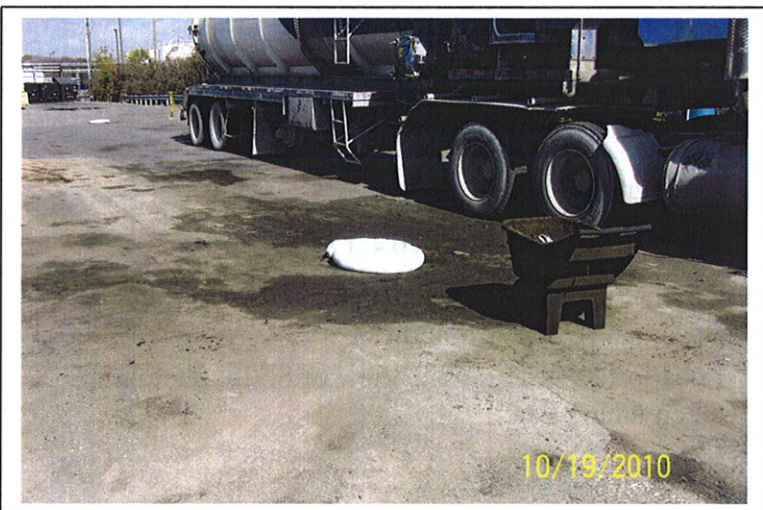
Location & Description: View of SS29, heavily soiled with sludge.
